Holderness coastline

Physical processes

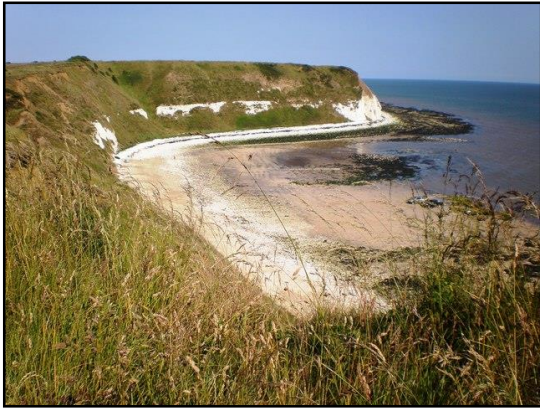
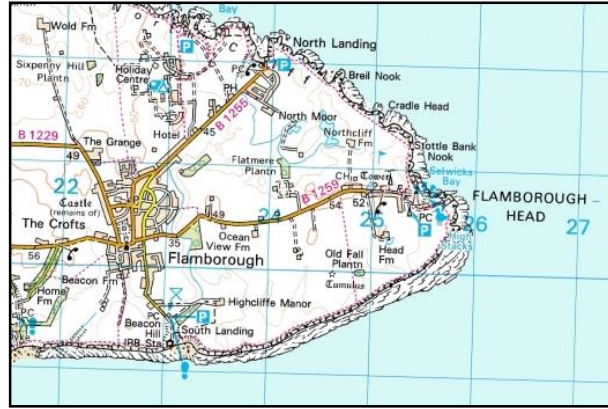
Flamborough Head – offers fabulous views out to sea – popular for Camping, but also popular for walkers with many car parks and footpaths to accommodate them.

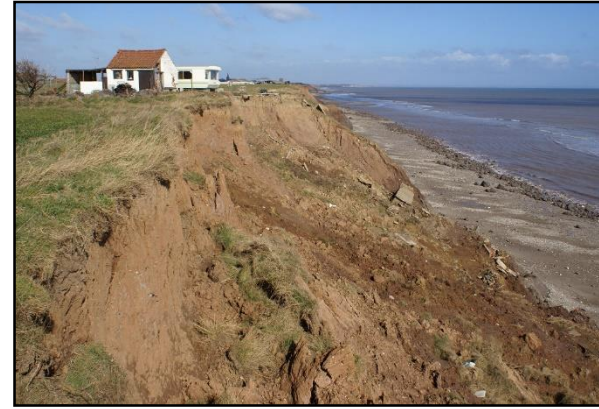
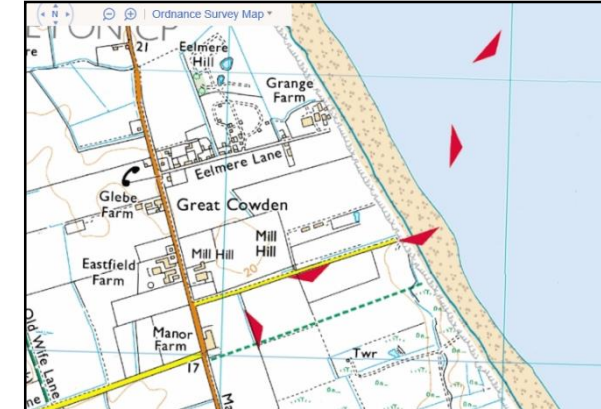
Great Cowden– small settlement, with abandoned homes due to rapid rates of erosion. Land not protected due to limited value of agricultural land.

Worryingly for Great Cowden is the very rapid erosion of beaches, cliffs and farm buildings here. This settlement is 3 km to the south and the sand being trapped by the groynes at Mappleton, may be limited the sand at Great Cowden. This means that the beach is narrower and provides less protection to the cliffs.

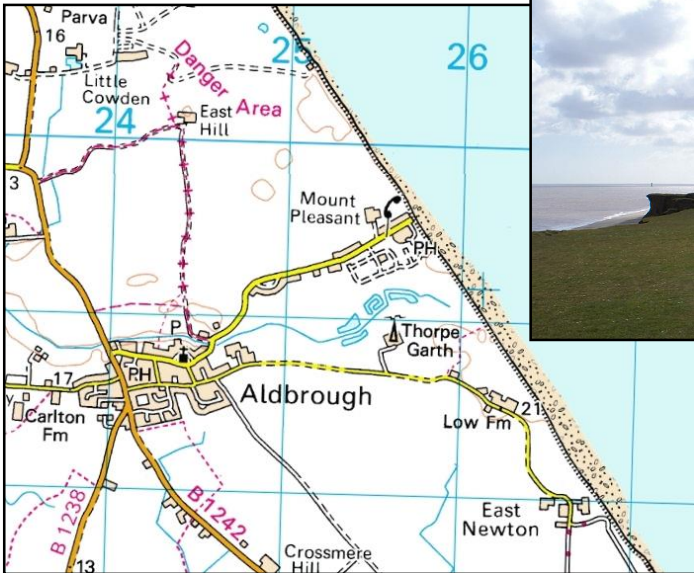
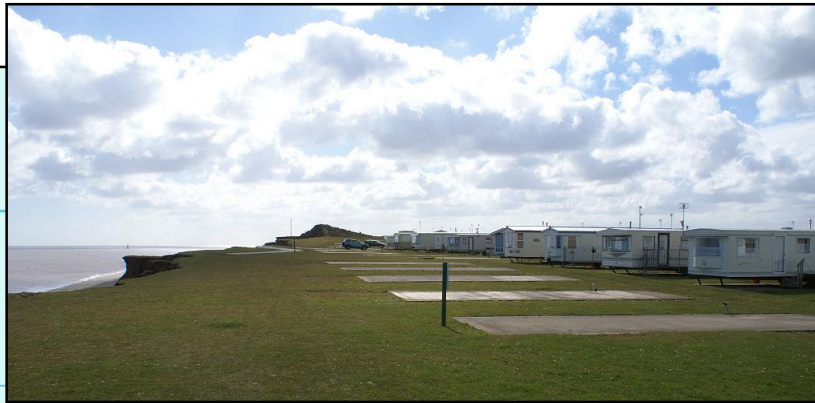
Aldbrough – some caravan parks are moving caravans back due to rapid rates of erosion. This has an impact of the tourism industry in the area (a negative multiplier effect).

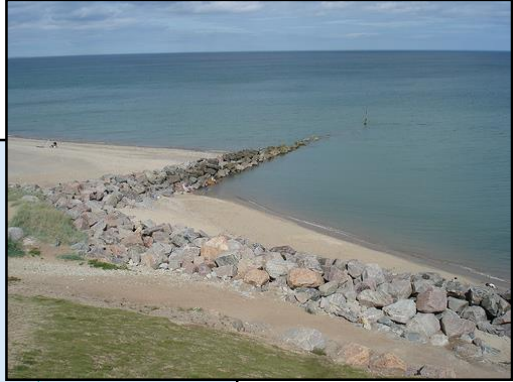
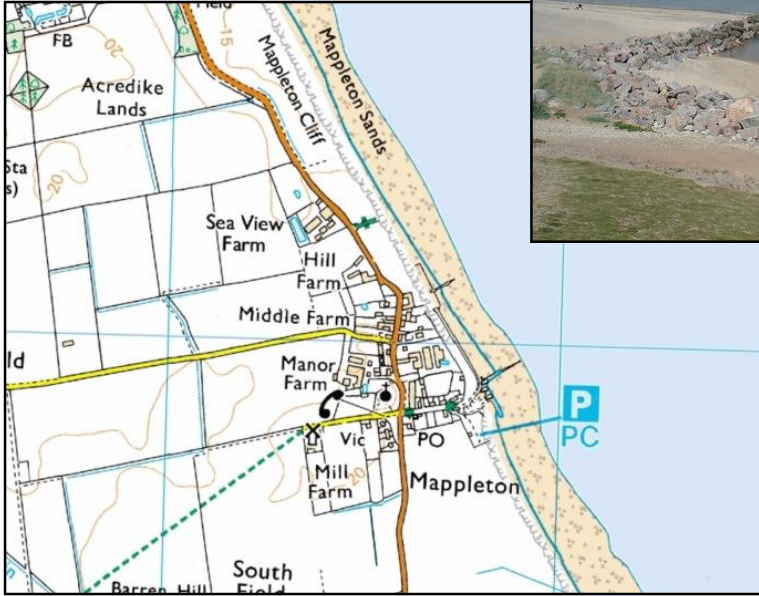
Mappleton– Rock groynes in place to stop longshore drift

Advantages – Two rock groynes are in place and are designed to trap beach sediment, along with a rock revetment to prevent erosion of the cliffs.

Disadvantages – beyond the second groyne the large rocks are being undermined (eroded) and the cliff face below the car park has begun to erode.

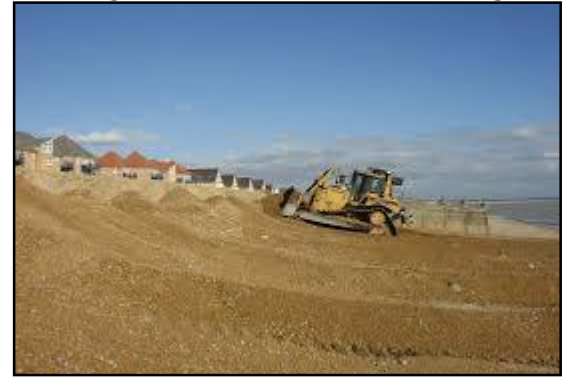
Mappleton– beach nourishment to add sand lost to longshore drift back onto the beach

At Mappleton, the cliffs themselves were re-graded to reduce slumping and there was some nourishment of the beach to encourage deposition.

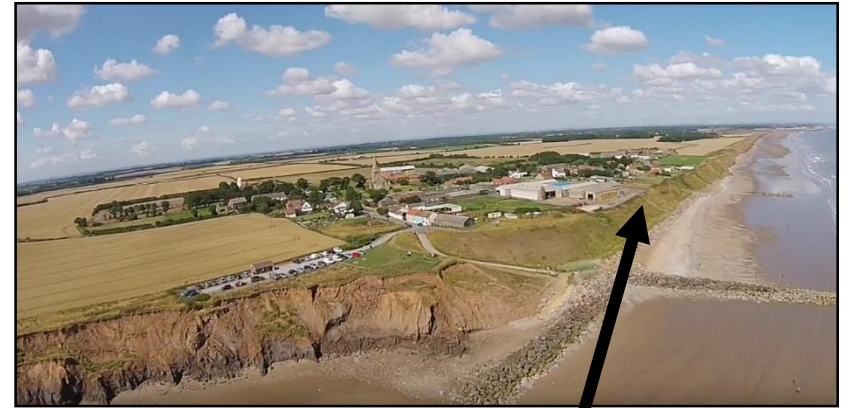
Mappleton– cliff regrading – changing the shape of the cliff to make it less steep – has occurred here

The regraded cliffs looked secure and so a new access road was built and a car park and toilets for visitors. However in 2002 all is not well. The re-graded cliffs behind are showing early signs of slumping.

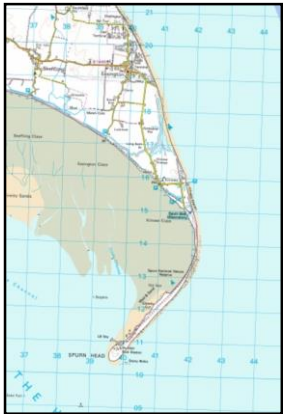
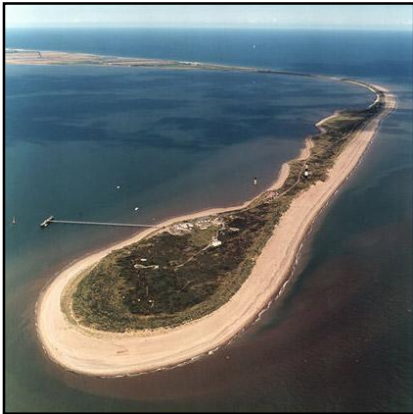
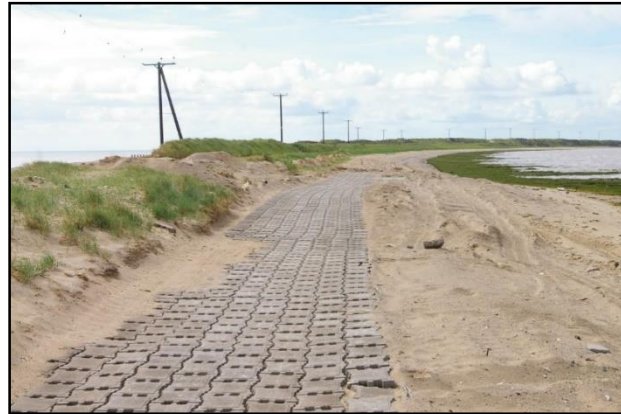
Spurn Head– Soft engineering strategies like matting to protect footpaths are no longer being invested in
